June 1999
Number 20

FRAME REPLACEMENT

by Ivan Henderson

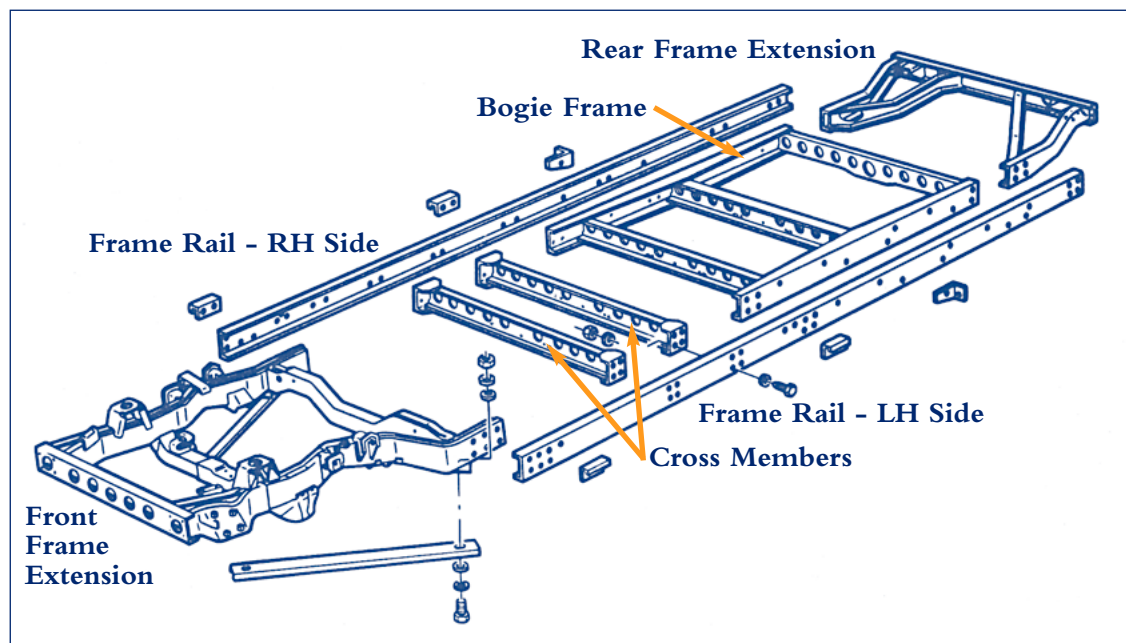
The frame sections that most often need to be replaced are the right and left side rails, the bogie cross members and reinforcements, and the rear frame extension. These sections tend to deteriorate because they are sandwiched together with one section bolted inside another section. Moisture is trapped between the two sections, and rust begins to form.

When inspecting a frame for rust, special attention should be given to the areas where the bogie

It is very unusual to find the front frame extension deteriorated badly enough to require replacement, but we have observed several coaches that have needed that portion of the frame replaced. Most of the time, the areas on the front frame that are rusted can be removed and repaired by a skilled welder. The single cross members that are located in the front area of the frame very seldom need replacing. Normally, they can be sandblasted,

painted, and reused in the new frame.
